TAT-8310-05

On 14 and 17 October 1983, officers from the Illinois Department of Law Enforcement, Division of State Police, and TAT member Stofferahn conducted inspections of six sites in the Chicago area being used to store cyanide contaminated film chips. These visits were made to assess the structural integrity of the semi-trailer vans which are holding the waste.

SPILL PREVENTION &amp; EMERGENCY RESPONSE DIVISION

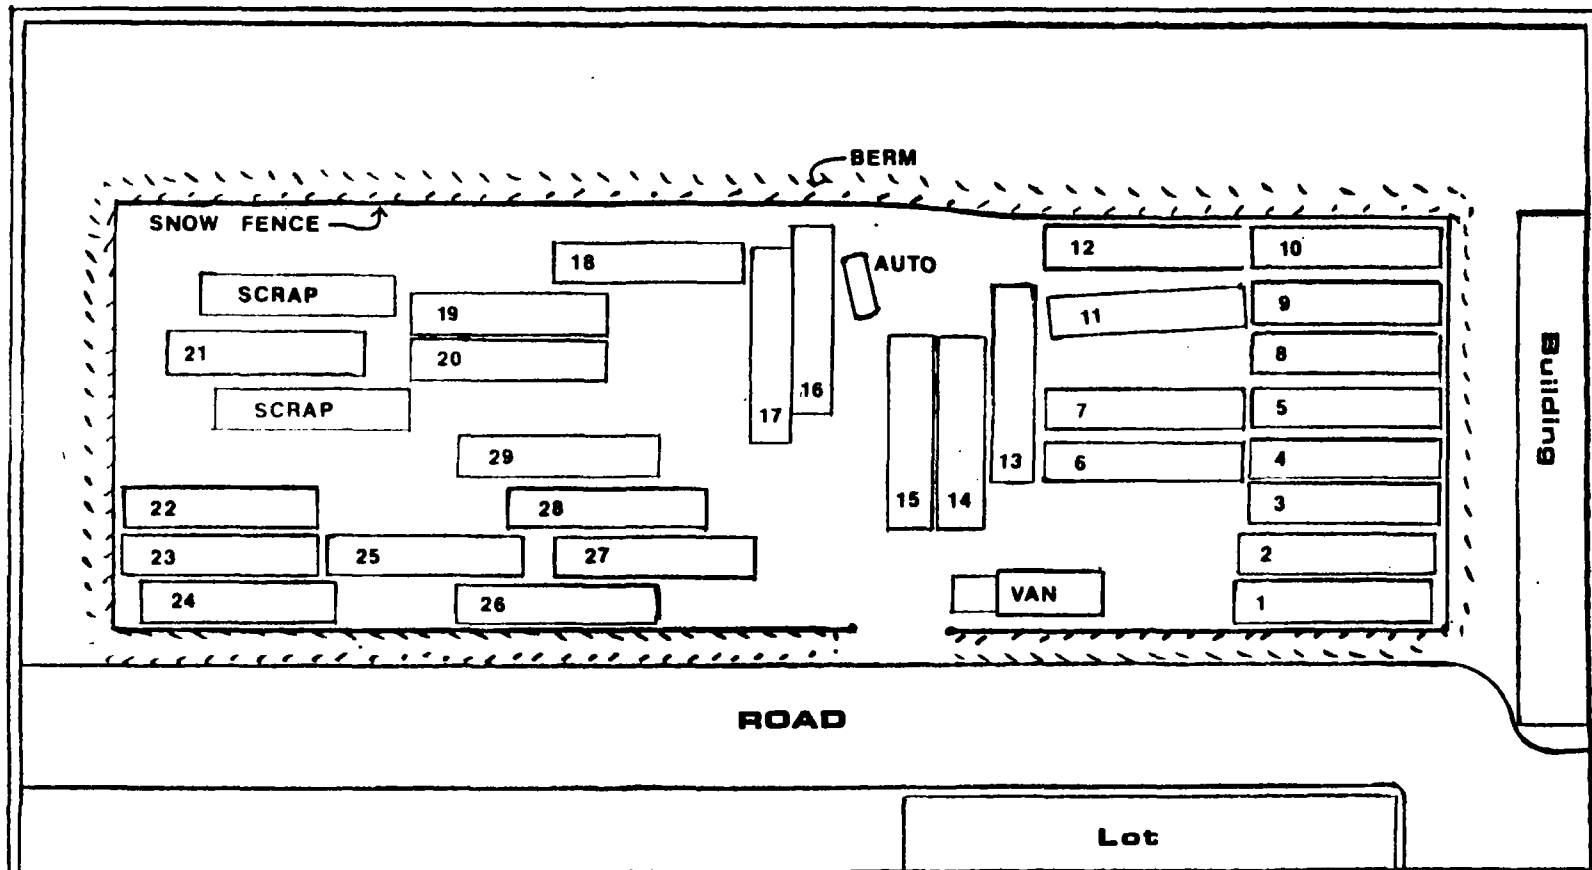
**Figure 1**

On 14 October 1983, TAT member Stofferahn met with Troopers Koch and DeLacy at District Three Headquarters of the Illinois State Police, 4051 N. Harlem Avenue, Chicago. After a brief explanation as to what the site assessments were to involve, the troopers and TAT proceeded to the Red Devil Manufacturing facility at 5995 North River Road, Rosemont, Illinois (Figure 1). Twenty-nine trailers were numbered with spray paint and categorized. The results of the assessment are given in Table 1. Trailer three was found to contain no waste chips. All other trailers were noted to be leaking or seeping leachate to some extent. Five trailers, numbers 13, 15, 18, 27 and 28, were recommended by the officers to be offloaded. The trailers are confined to a small bermed area, and little room to access the majority of the trailers exists. A small asphalt lot was noted across the street from the site which could potentially be used to temporarily store the structurally sound units while the others are being repaired or off-loaded. No information as to the owner of this lot was available at this time.

<u>Trailer #</u>	<u>Category</u>	<u>Comments</u>
1	B	Clear side door and seal
2	C	Patch front seam
3		No waste found inside
4	B	Locked
5	B	Clear rear door
6	C	Front seams corrosion
7	C	Repair back door
8	C	Clear doors and seal
9	C	Seam corrosion
10	B	Locked
11	C	Repair rear door
12	C	Repair rear door
13	D	Waste leakage through floor hole
14	C	Front seam corrosion
15	D	Front and sides leaking chips
16	C	Repair back door, side seams corrosion
17	B	Clear door of chips
18	D	Sides of leaking chips
19	C	Replace back door
20	C	Reinforce floor, front seam corrosion
21	B	Corroded seams
22	C	Seam corrosion, reinforce door
23	B	Clear door seams of chips
24	B	Clear door seams of chips
25	C	Reinforce floor, front side seam corrosion
26	C	Repair rear door
27	D	Chip leakage at doors
28	D	Chip leakage at doors
29	C	Reinforce floor, clear doors

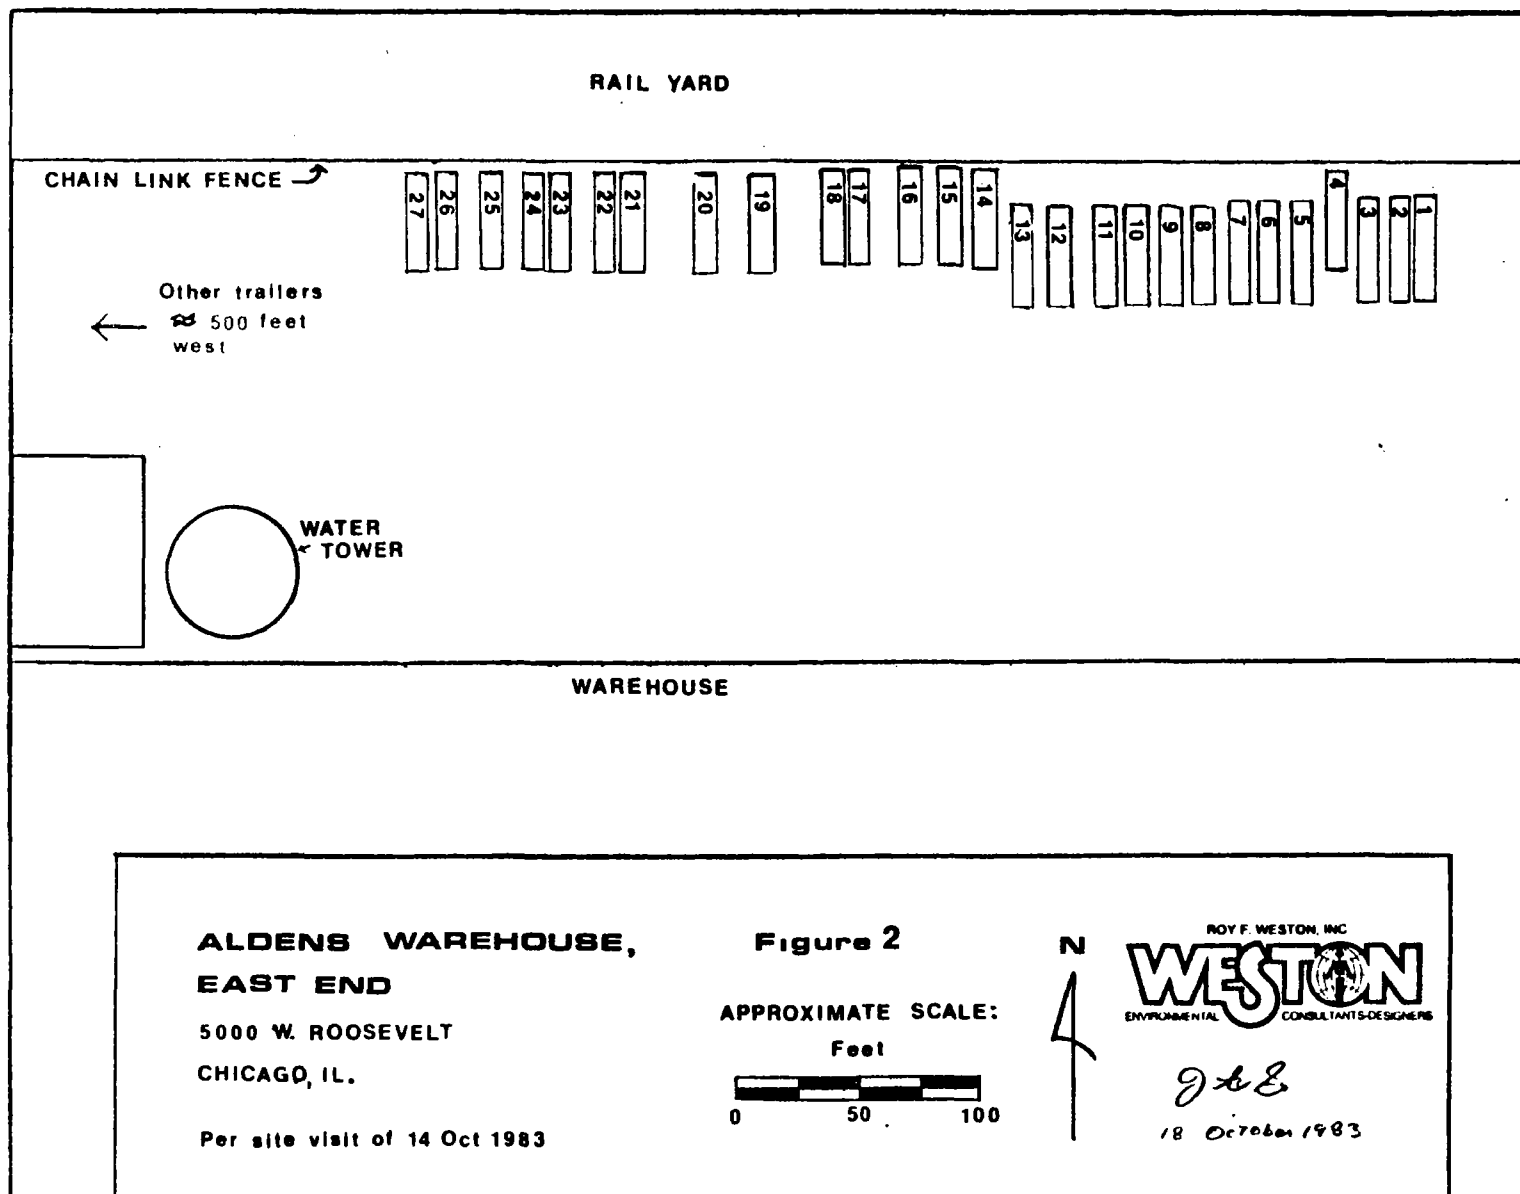
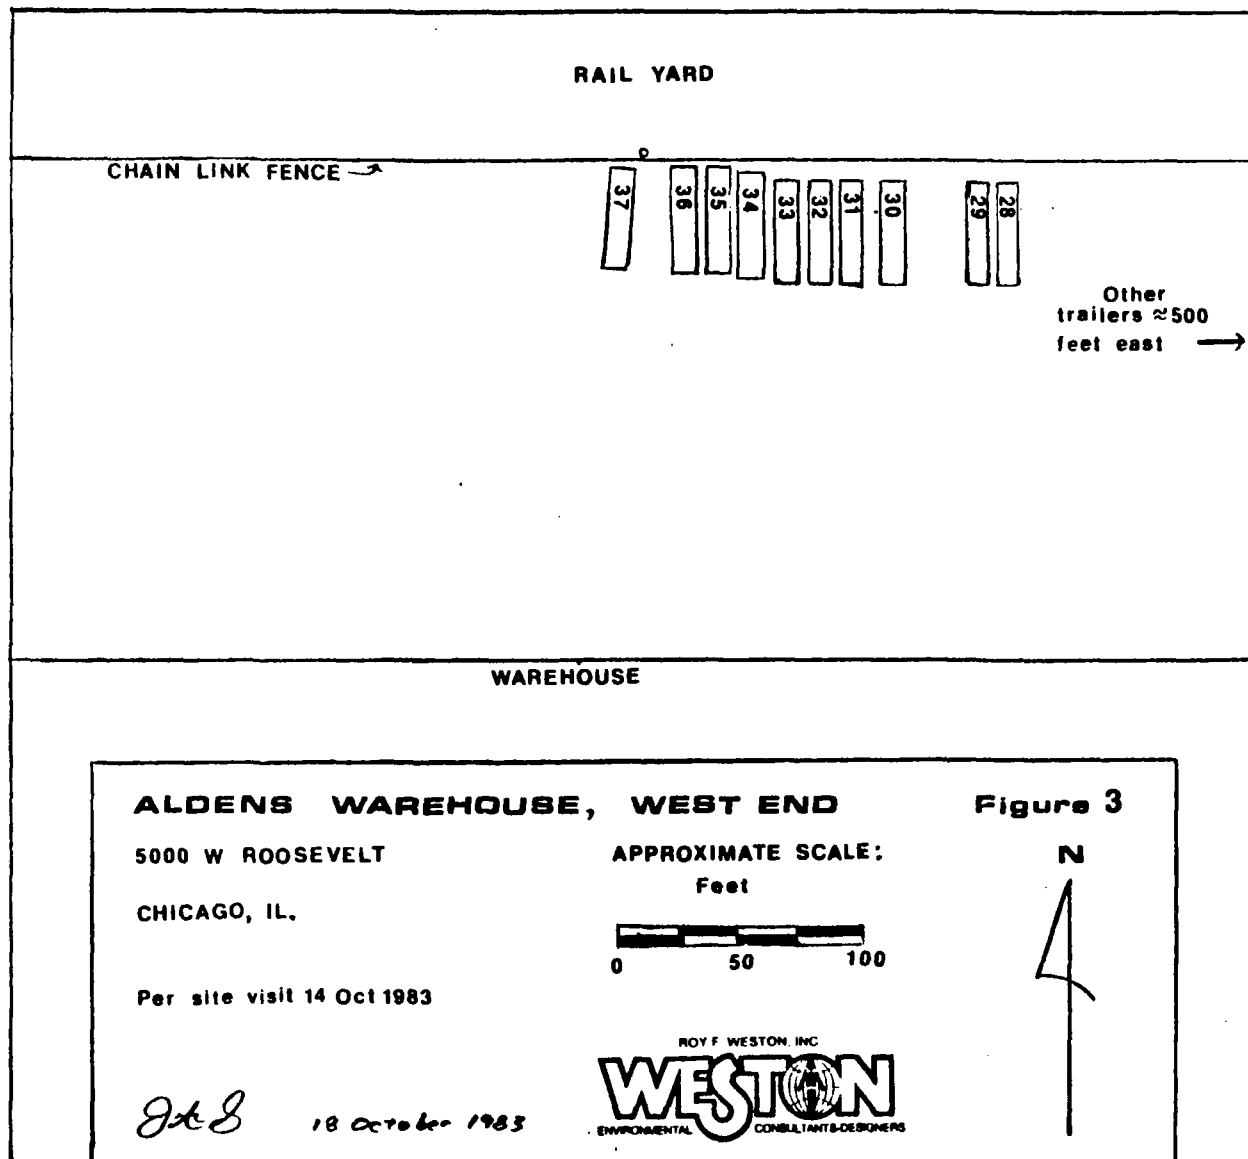
From the Rosemont site, the troopers and TAT proceeded to the abandoned Aldens warehouse site at 5000 W. Roosevelt, Chicago (Figures 2 and 3). Thirty-seven trailers containing chips were numbered with indelible markers. Twenty-seven of these trailers contain chips which were treated with sodium hypochlorite solution by Petrochem Services, Inc., during a state-funded Emergency Action this last summer. Recent analyses, however, have shown these chips still contain significant levels of cyanide and were included in the assessment. The results of the assessment are given in Table 2. Again, all the trailers showed signs of leakage or seepage of leachate (as the weather has been relatively dry prior to the site visits, most of the trailers at this and the Rosemont site were not actively leaking, but showed definite signs of past leakage). The troopers recommended that ten trailers, numbers 2, 3, 5, 11, 17, 30, 32, 33, 34 and 35, should be off-loaded. The trailers are situated on a

<u>Trailer #</u>	<u>Category</u>	<u>Comments</u>
1	C	Repair floor
2	D	Chips leak at seams, sides bulging
3	D	Front bulging, seams leaking
4	B	Corrosion at door and seams
5	D	Floor and back door unstable, leaking chips
6	C	Repair floor
7	C	Repair floor
8	B	Clear back door
9	C	Front seam corrosion, reinforce back door
10	C	Seam corrosion, seal back door
11	D	Sides bulged, chips leaking at rear
12	C	Seam corrosion, clear rear door
13	B	Clear rear door
14	C	Repair rear door
15	C	Seam corrosion, replace rear door
16	C	Clear rear door, front seam corrosion
17	D	Hole in floor, sides corroded
18	C	Front seam corrosion seal rear
19	C	Seam corrosion
20	C	Seam corrosion
21	C	Seam corrosion
22	C	Seam corrosion
23	C	Seam corrosion
24	C	Seam corrosion
25	C	Seam corrosion
26	C	Seam corrosion
27	C	Seam corrosion
28	C	Seam corrosion
29	C	Seam corrosion
30	D	Sides bulging
31	C	Seam corrosion
32	D	Unstable sides and rear
33	D	Leakage of chips through side corrosion

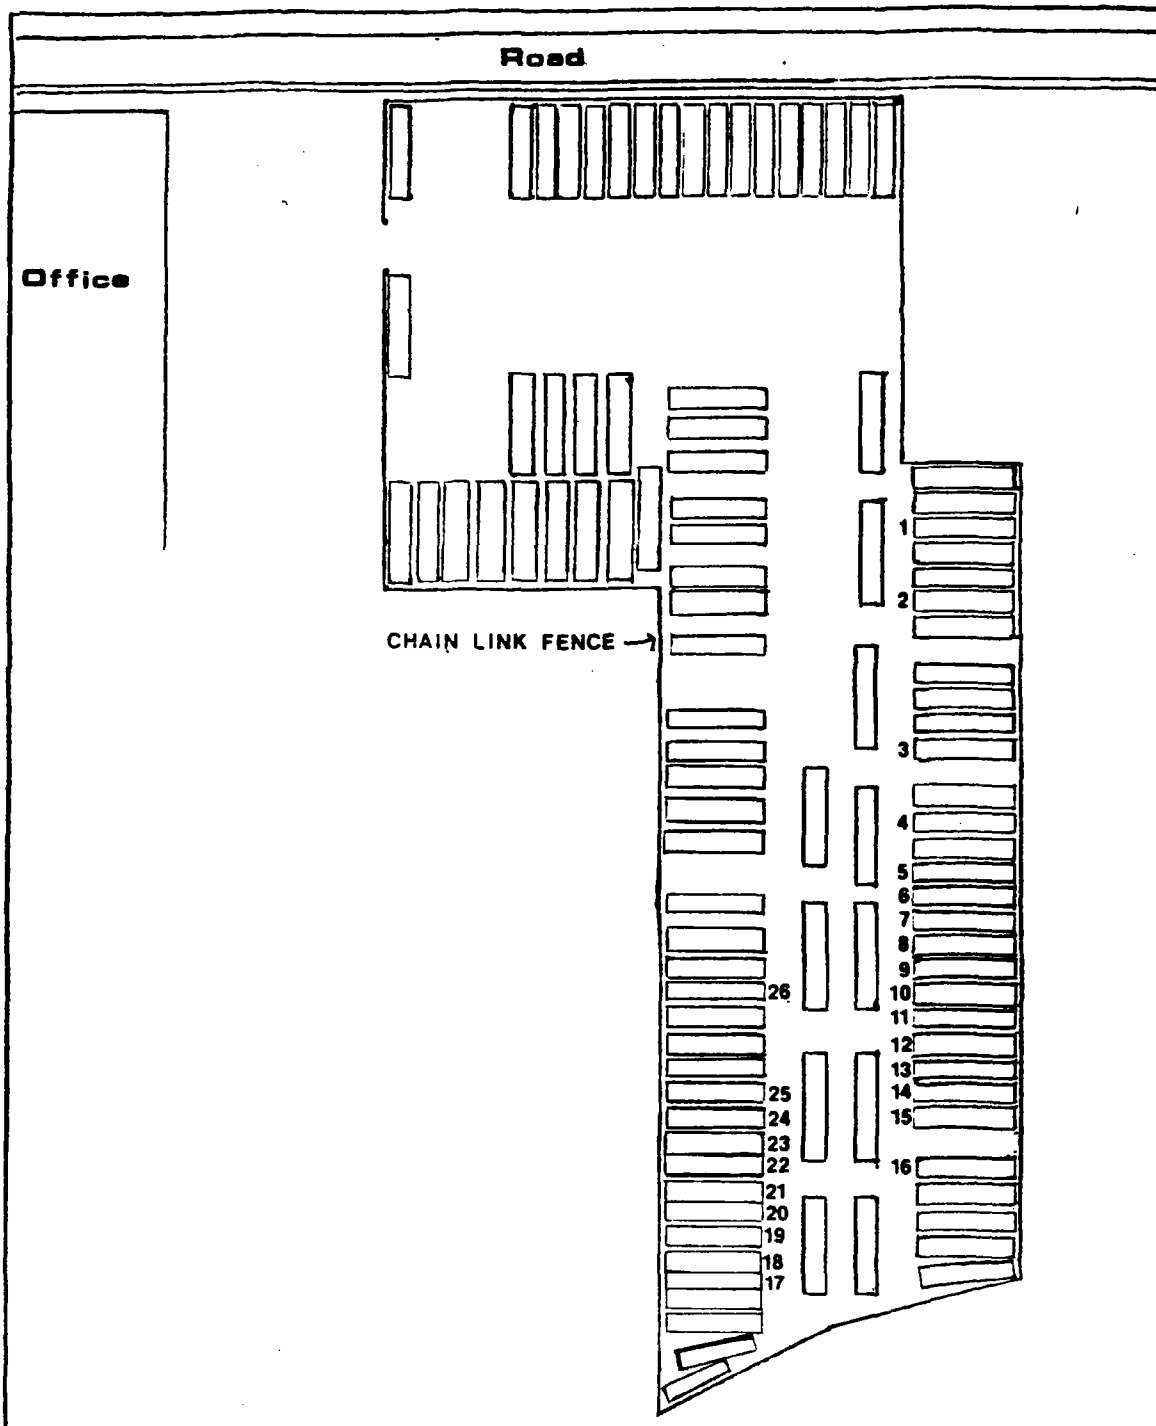
**GEMINI LEASING (RITE-WAY) Figure 4**

On 17 October 1983, TAT member Stofferahn met with Sargent Underwood and Troopers Zipsie and Patterson from District Four State Police Headquarters (13863 S. Cicero, Crestwood, Illinois) at the Gemini Leasing yard, 6021 S. East Avenue, Hodgkins, Illinois (Figure 4). The Gemini Leasing yard is an active facility. Twenty-six trailers containing waste chips located here were numbered with indelible markers. The results of the assessment of these trailers are given in Table 3. Most of the trailers were leaking; some were without jack stands. Nine trailers, numbers 11, 12, 14, 17, 19, 22, 23, 25 and 26, were recommended for offloading by the troopers. While gaining access to the twenty-six trailers will require only a minimal amount of movement of other units on the yard, acquiring room for repairs and offloading will be a problem due to the fact that this is an active place of business. The owner of the yard, who TAT met briefly during the site visit, complained that the waste trailers were taking up space on his yard which he could be utilizing for paying customers. The addition of ten more trailers, or several roll-off boxes, to store the chips from the ten unsound units is not anticipated to elicit a favorable response from Gemini officials.

<u>Trailer #</u>	<u>Category</u>	<u>Comments</u>
1	B	Leaking at front
2	B	Leaking at front
3	B	Leaking at front
4	C	Repair side door, sides bowed
5	C	Side door sprung, leaking
6	B	Leaking - floor rotting
7	A	
8	C	Floor rotting, sides sprung from frame
9	C	Side walls sprung, seam corrosion
10	C	Seam corrosion
11	D	Holes in side, floor rotting
12	D	Holes in side, floor near collapse
13	C	Side seam corrosion, floor leakage
14	D	Side corrosion, floor leakage
15	C	Side walls sprung, leaking
16	C	Side corrosion, leaking
17	D	Side corrosion, leaking
18	C	Front seam corrosion, leaking
19	D	Side corrosion, leaking
20	B	
21	C	Minimal side corrosion, leaking
22	D	Top damaged, side walls sprung, leaking
23	D	Side walls sprung, front and side seam corrosion
24	C	Front seam corrosion, leaking
25	D	Floor buckled, sides bowed, leaking
26	D	Side corrosion, leaking

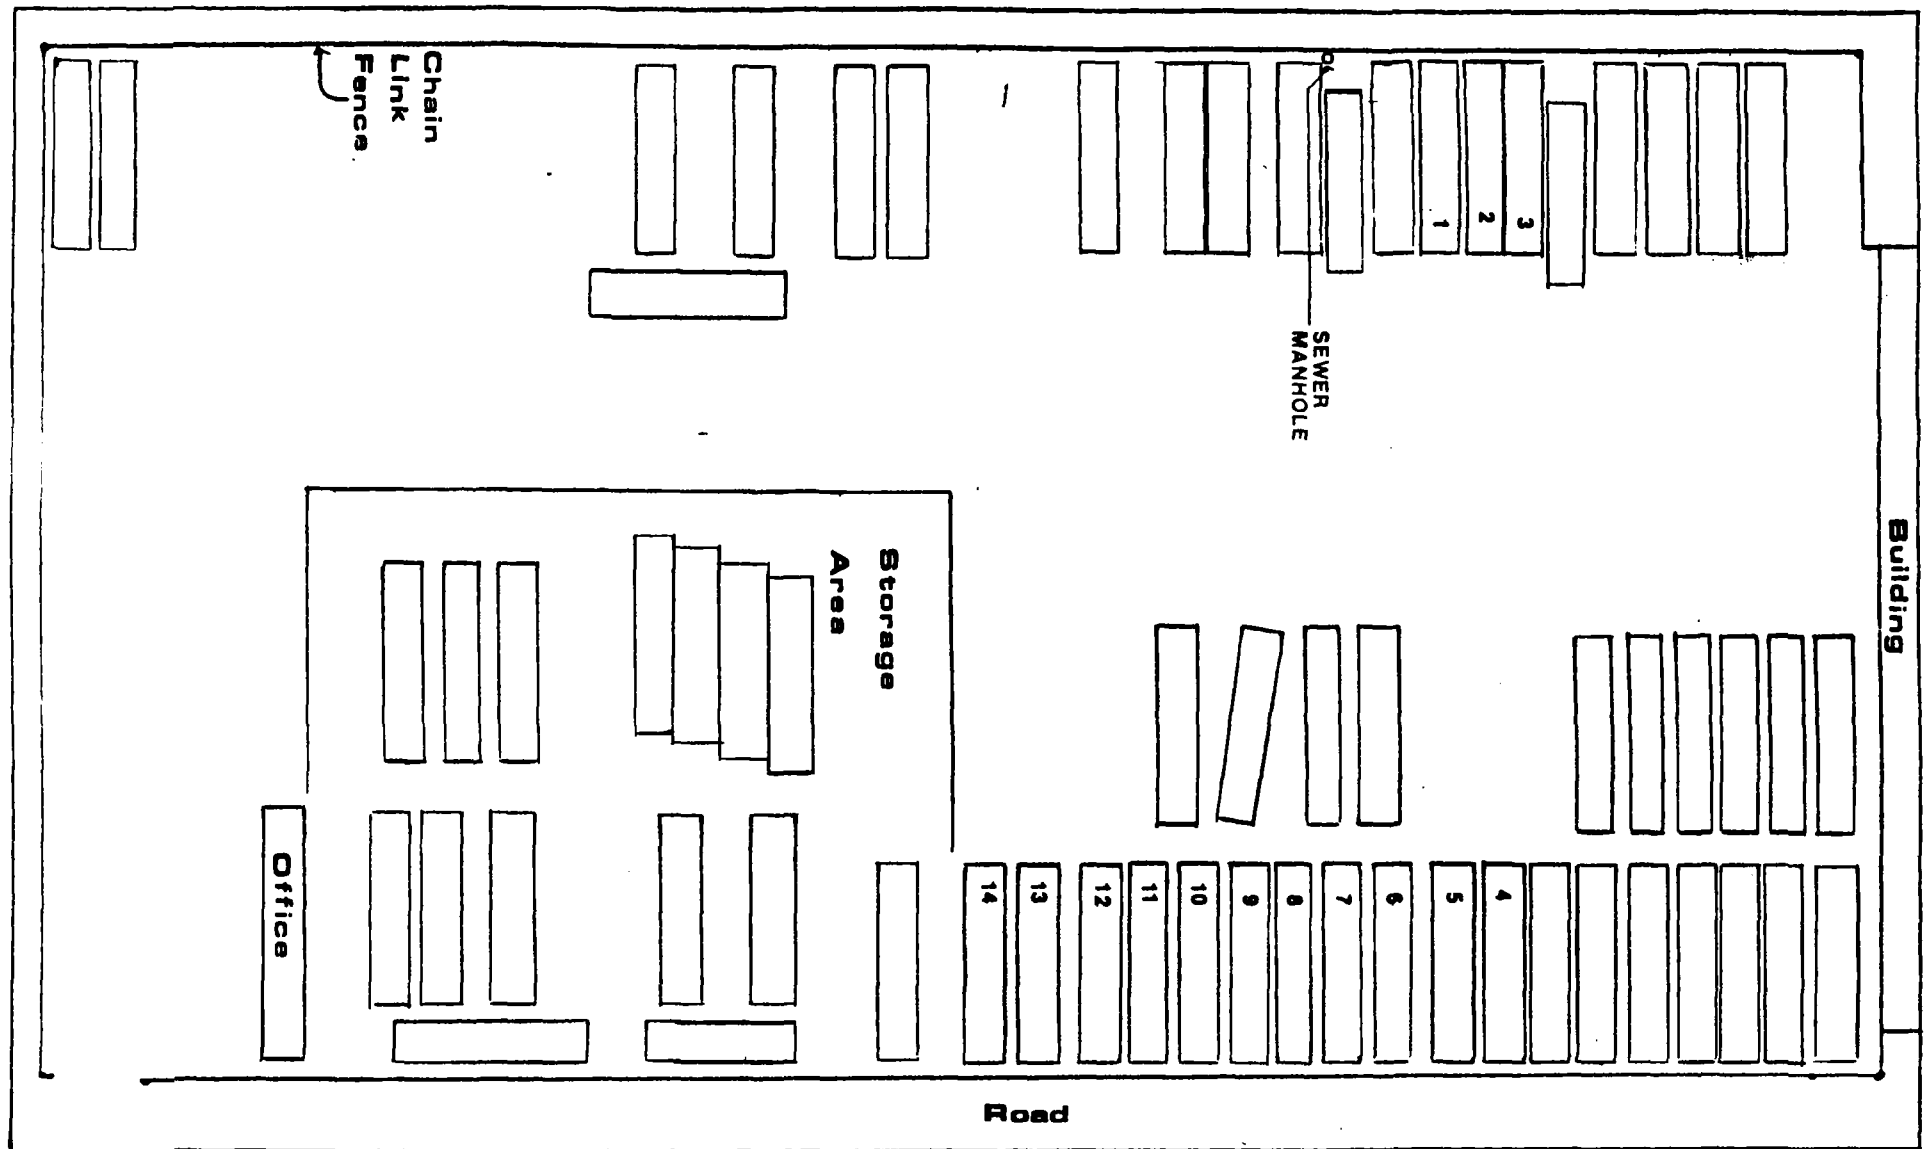
Figure 5

The next site assessed was J's Mobile Semi-Trailer Repair yard at 8765 W. Joliet Road, McCook, Illinois (Figure 5). Fourteen trailers located here were numbered and assessed. The results of the assessment are given in Table 4. Leakage of leachate from these trailers had been found to be migrating off site via a storm sewer by personnel from the Metropolitan Sanitary District of Greater Chicago (MSD) in September of 1983. Four trailers, numbers 1, 3, 6 and 7, were recommended to be offloaded. As with the Gemini Leasing yard, this is an active trailer yard. Access to the waste trailers is not anticipated to be a serious problem; however, finding enough room for repairs and offloading is.

<u>Trailer #</u>	<u>Category</u>	<u>Comments</u>
1	D	Rear door missing, side and front corrosion
2	C	Possible frame damage, side corrosion
3	D	Floor in very bad condition
4	B	Floor leakage
5	C	Rear seam corrosion
6	D	Much floor rotting
7	D	Floor buckled, considerable seam corrosion
8	C	Right side corrosion, clear rear door
9	C	Front and left side corrosion
10	C	Cross member in floor bowed and twisted, side corrosion
11	B	Leaking at rear door
12	C	Side corrosion
13	C	Side corrosion
14	A

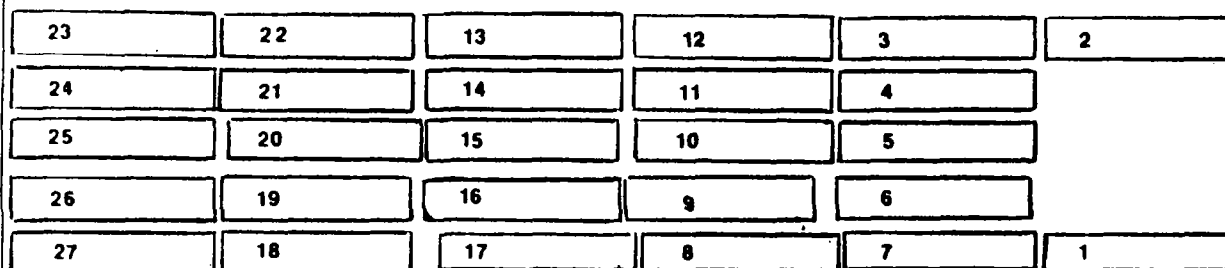
**EAGLE TRAILER INC. Figure 6**

The Eagles Trailer yard at 7710 W. 57th Street, Summit, Illinois (Figure 6), was the next site visited. Twenty-seven trailers containing waste were numbered and assessed. The results of the assessment are given in Table 5. As with the J's site, off-site migration of cyanide via a drainage ditch along the southern parameter of the site was documented by the MSD last September. Three units, numbers 2, 4 and 16, were recommended for off-loading. A considerable access and congestion problem was noted at this site. There is a totally inadequate amount of space within the area where the trailers are parked for any amount of work to be done. The trailer repair yard to the north is active, and cannot be used. The paved area leading to Archer Avenue could be used for temporary storage of sound units. To the northeast, TAT noticed a very large paved parking lot and what appeared to be abandoned buildings. This lot could also potentially be utilized for temporary storage or working space. An Eagle's employee stated this facility was owned by Ryder P.I.E., and supplied TAT with a business card for a contact with the firm (Attachment 1).

<u>Trailer #</u>	<u>Category</u>	<u>Comments</u>
1	B	
2	D	Side corrosion
3	B	
4	D	Side corrosion
5	B	
6	B	
7	B	
8	C	Side corrosion
9	B	Leaking side door
10	B	Leaking side door
11	B	Leaking floor
12	B	Leaking side door
13	B	Leaking floor
14	B	Leaking sides
15	B	
16	D	Side seam corrosion, side door sprung
17	B	Leaking sides
18	B	Leaking front
19	C	Front upright brace cracked, front seam corrosion
20	B	Leaking side
21	A	
22	B	Leaking floor
23	B	
24	A	
25	A	
26	B	Leaking side
27	B	Leaking floor

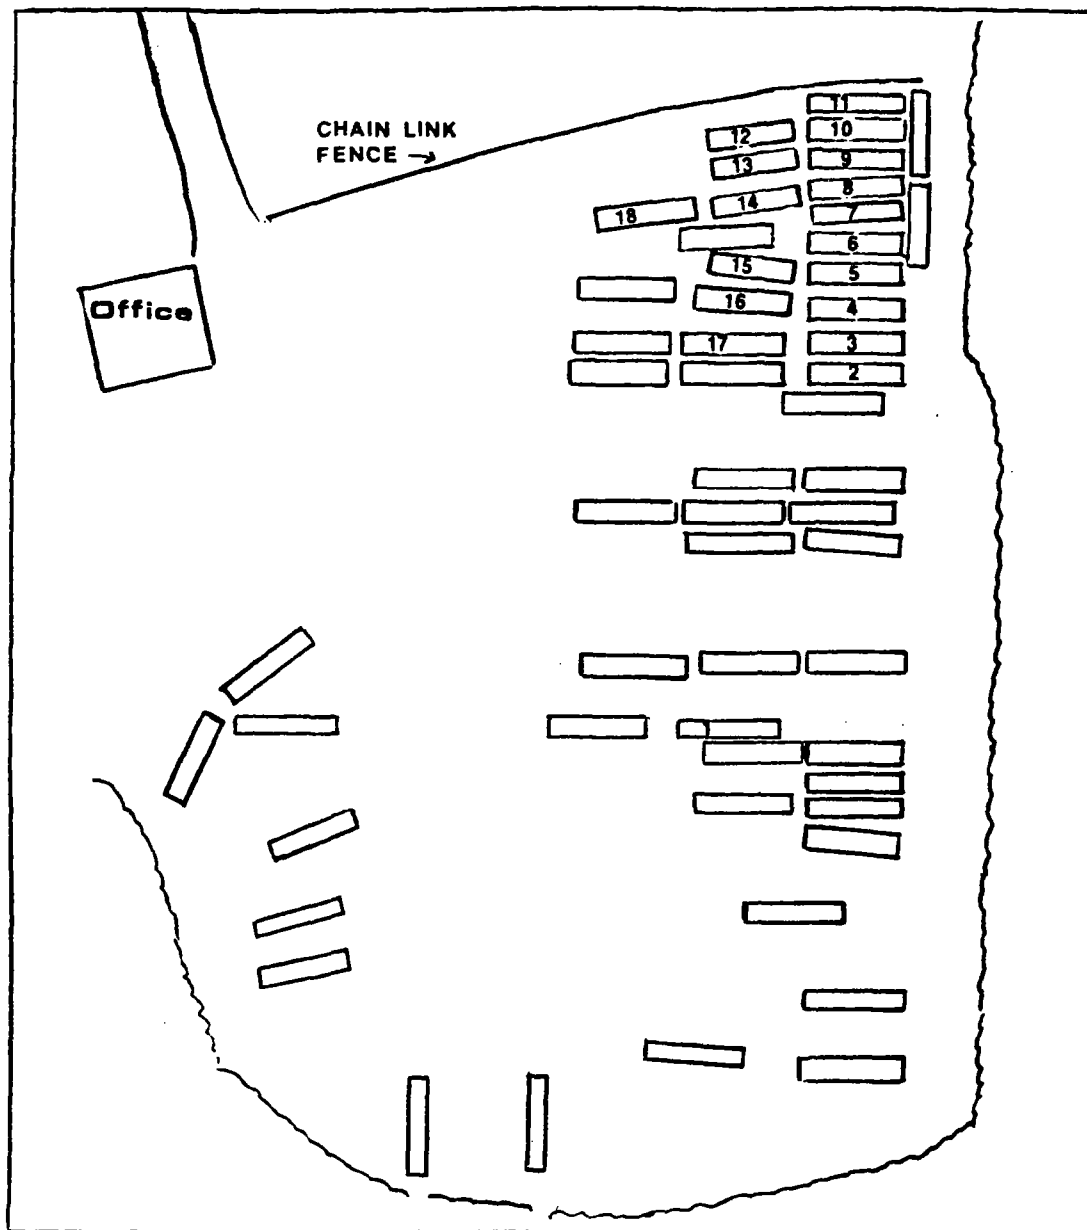
**Figure 7**

The Livco trailer yard at 6700 W. 130rd Street, Chicago Ridge, Illinois, (Figure 7), was the last site visited. Eighteen trailers containing waste were numbered and inspected at this facility. Table 6 provides the results of this assessment. All the units were leaking or seeping leachate, but only one, number 55, was recommended for offloading. While this is also an active facility, no significant access or congestion problems are anticipated.

<u>Trailer #</u>	<u>Category</u>	<u>Comments</u>
1	B	
2	B	Leaking floor
3	B	Leaking floor
4	B	Leaking floor, front seam
5	D	Side seam corrosion, possible collapse
6	B	Front seam corrosion
7	B	Leaking floor
8	B	Leaking floor
9	B	Leaking floor
10	B	Leaking floor
11	B	Leaking floor
12	B	Front seam corrosion
13	B	Leaking floor
14	B	Leaking floor
15	C	Front seam corrosion, possible collapse
16	B	Leaking floor
17	B	Leaking floor, front seam corrosion
18	B	Leaking floor, side seam corrosion
